# Impact Of a Low-Income Informal Settlement in a Headwater Area at High-Risk Of Erosion in Brazil

**Abstract** - The largest remaining area of preserved Atlantic Forest in the Belo Horizonte City (Minas Gerais, Brazil) protects many headwaters and watercourses. Among them, the Macacos stream is considered the most preserved with high water quality. However, since 2013 this region has suffered an intense and disorderly of informal settlement process by low-income communities, which resulted in a progressive loss of the original vegetation. Due to the lack of vegetation, this area became prone to erosional process as demonstrated by the topographic analysis. The Normalized Difference Vegetation Index (NDVI) demonstrated the great impact of the settlement process over the vegetation, ranging from 1 to 0. Besides, this eroded area has faced the loss of biodiversity as estimated by the richness and Shenon's index as well as the invasion by exotic species as *Brachiaria sp* and *Typha domingensis*. Also, the erosional process in this hilly site resulted in the accumulation of high level of sediments in the Macacos stream. Therefore, the restoration of headwaters and riparian sites aimi

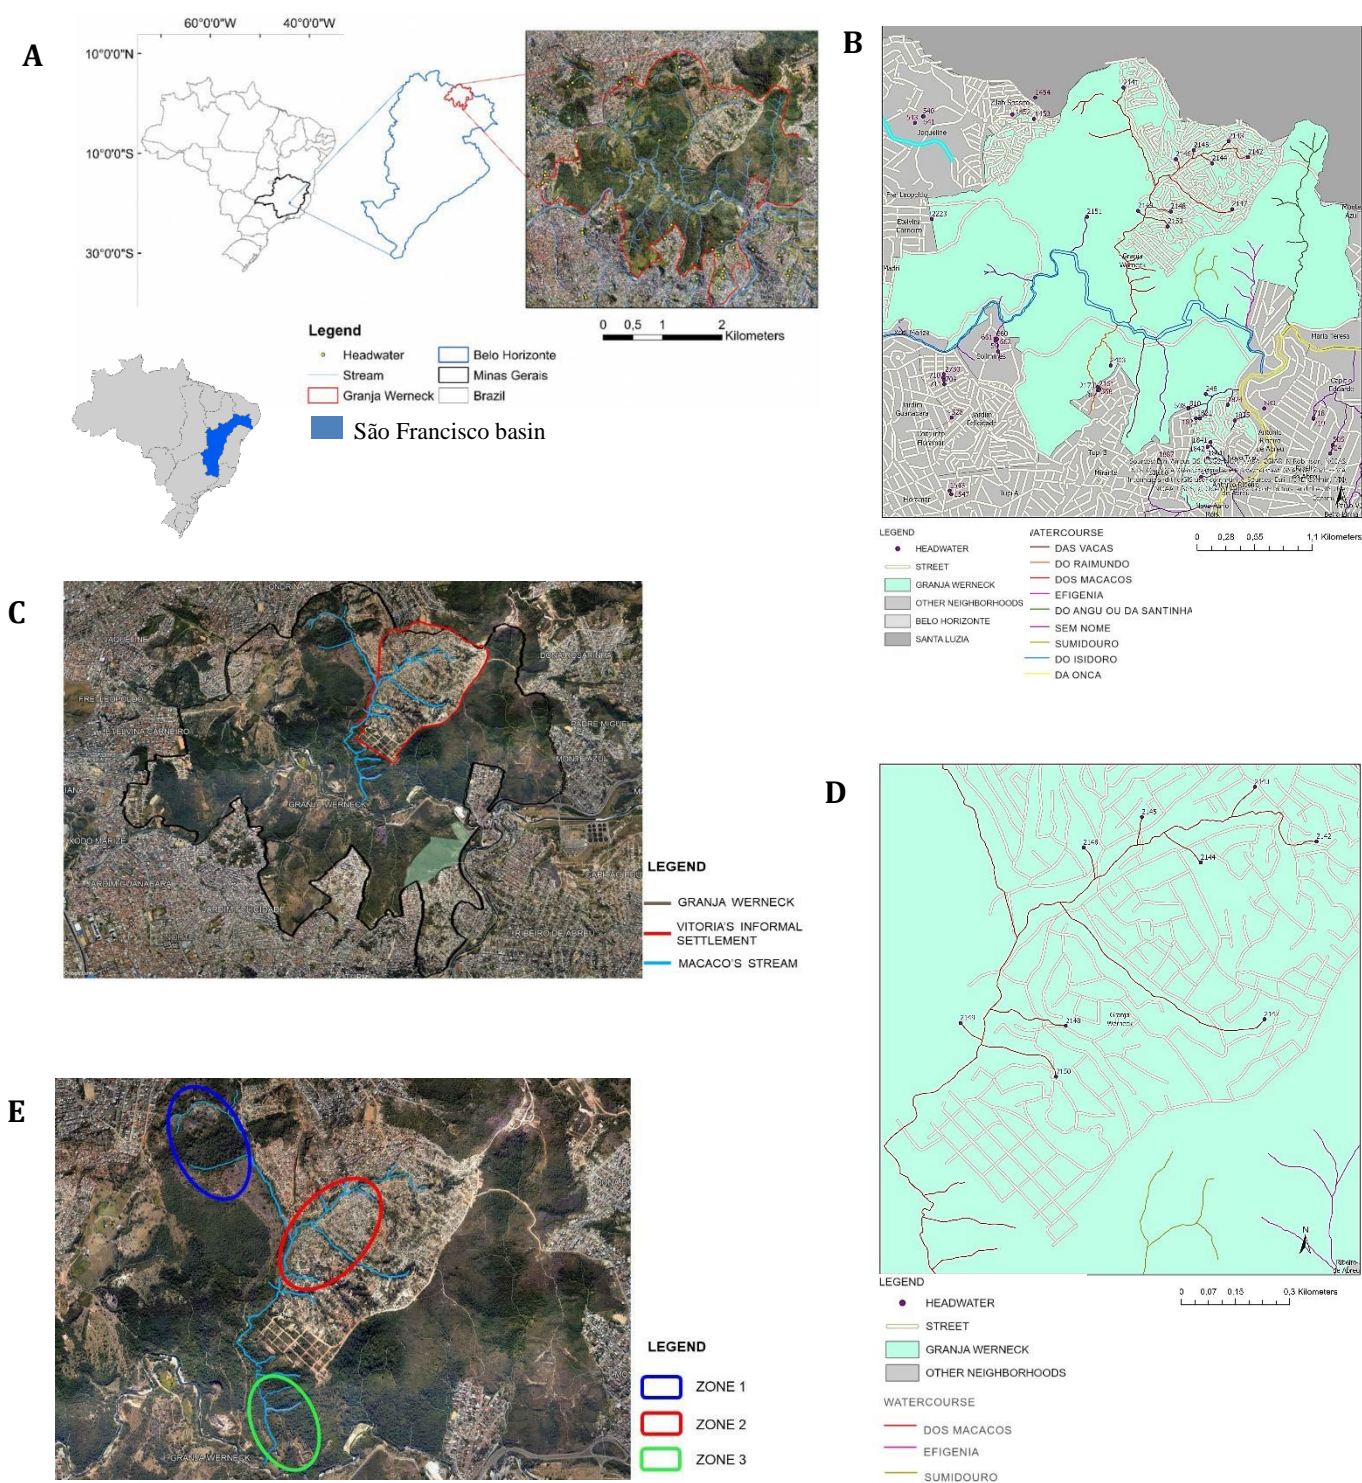
Figure 1. (A) Location of study area of Isidora micro-basin (Minas Gerais Brazil). (B) Hydrological map (C) Vitoria's informal settlement in Granja Werneck. (D) Macacos stream and headwaters catalogued by the City of Belo Horizonte Map. (E) Delimitation of the zones of environmental impact.

The largest preserved area belonging to the Atlantic Forest biome in Belo Horizonte City (Figure 1A) (19°48'53.58"S, 43°54'52.09"W) is located at the

Izidora micro-basin of the São Francisco River basin (Minas Gerais, Brazil) and comprises 950 hectares, which corresponds to three times the area of the Central Park in New York City (341 hectares). This site hosts around 280 headwaters and forms 64 streams (Figure 1B), being the Macacos stream (2,6 km<sup>2</sup>) the most preserved in terms of water quality, discharge and riparian forest preservation and extent [1]. However, this site has been suffering an intense process of informal settlement by low-income populations, resulting in the deforestation and degradation of this region. The Victoria informal settlement (Figure 1C) is currently inhabited by 4.500 families [2], which has disorderly occupied a top-mountain area, where several headwaters co-exist (Figure 1D). Consequently, this site has become prone to erosional processes associated with the loss of vegetation and water. In addition, the disorderly urbanization process has produced land fragility and instability, particularly because the houses and urban constructions have been built over some headwaters and along stream subjected to flooding events. Therefore, this has produced some urban pathologies related to damages to the houses such as infiltrations and wall cracks, resulting in a poorer life quality for this low-income community.

The study site is located in the north region of the city of Belo Horizonte in the São Francisco's basin (Fig. 1A). This area has been suffering an impact of the disorderly urban informal settlement process, with loss of vegetation and threatening the stability of the soil in the region.

For the floristic analysis, the area was divided into three zones (Fig. 1E) alongside the Macaco stream. The blue zone is characterized by the portion that comprised the majority of the headwaters of the basin but is still subjected to some impact from the urban settlement (Fig. 1E). Zone two (red) refers to the stream fragment along the Vitoria's settlement that is most impacted by the Vitoria's informal settlement. Zone three (green) is the stretch of the Macaco stream which corresponds to a preserved area of Atlantic Forest. The experimental design was composed by three blocks corresponded the three zones mentioned above. Each block was divided in three transects of 30 meters where the plants were sampled. In each transect, it was sampled 3 plots of 5m<sup>2</sup> per plot totalizing 27 samples. All vascular plants, including both in the flowering stage and in the vegetative stage, found inside the plots were sampled according to Braun-Blanquet (1979) [8]. The specimens collected were herborized and deposited at the BHCN herbarium after taxonomic identification.

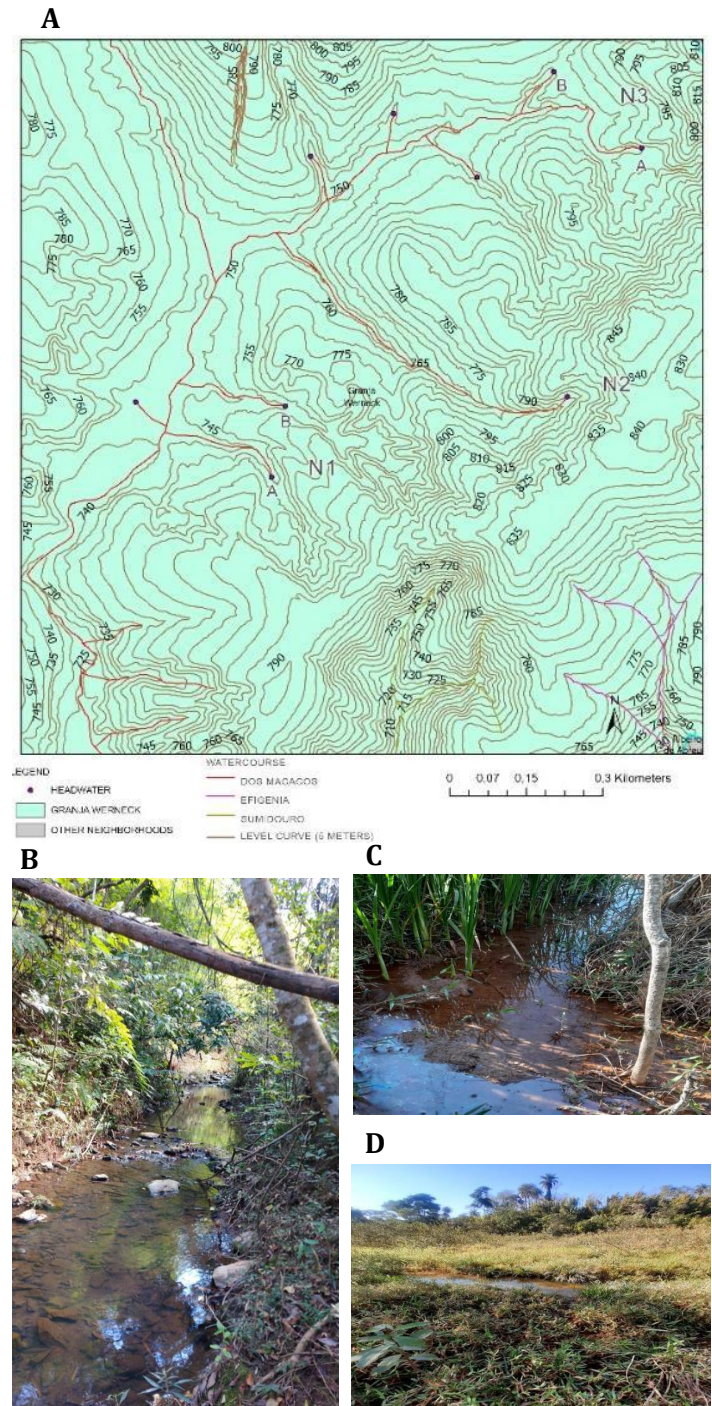
Figure 2. (A) Topographic analysis of Macacos stream and the study area. (B) Preserved stretch of Macacos stream. (C) Sediments in Macacos stream. (D) Invasive vegetal species in Macacos Stream.

The figure 2A shows that the Vitoria's informal settlement was established on an area at high risk of water erosion, originally composed of several headwaters where the vegetation was completely lost. The altitude difference from 725 to 840 revealed the erosive potential of this area considering the inclination as well as the presence of headwater and streams across the area. Surface water runoff is intensified during rainy season allowing the movement of sediments, further accelerating the erosive process.

Although the Macacos stream may be considered still preserved at the zones 1 and 3 (figure 2B), the Vitoria urbanization has impacted the streams with high level of sediments in zone 2 (figure 1E), leading to the massive invasion by exotic species such as *Brachiaria* sp and *Typha domingensis* (figure 2 D). The satellite images captured until 2013 (figure 3A) shows that the land was preserved with a NDVI index around 1. However, after 2013, there occurred a progressive and accelerated loss of vegetation from 2017 to 2019 with a NDVI index of 0.4 (figures 3B e 3C). In the last two years (2020 and 2021), the NDVI index drop dramatically, revealing a severe loss of vegetation cover and a serious threat to the several headwaters (figures 3D and E). Such vegetation loss was particularly accentuated after 2017 as shown by the NDVI indices, as a consequence of the rapid, intense and disorderly process of urbanization of this area. However, the region surrounding the Vitoria urbanization has also suffered an impact on its vegetation structure, especially after 2019 (figure 3C), which was attributed to the large

contribution of sediments (figure 2B) from the collapsing erosions.

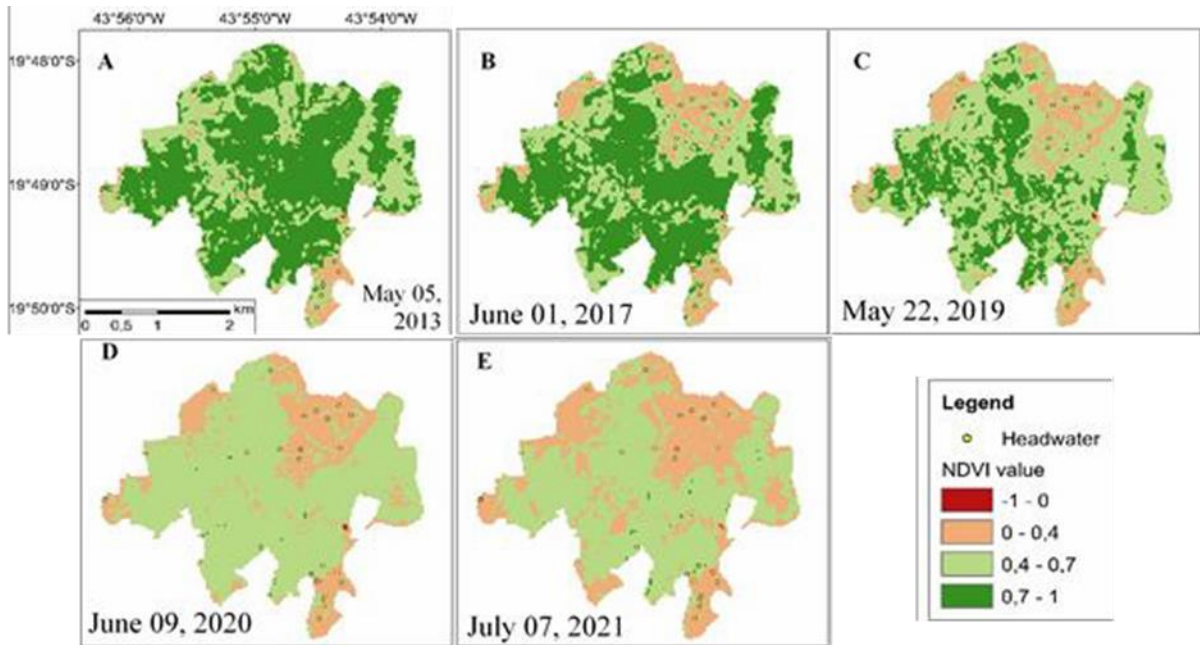
Figure 3. Normalized Difference Vegetation Index (NDVI) of the Granja Werneck region for the analysed images obtained in the years (A) 2013, (B) 2017, (C) 2019, (D) 2020 and (E) 2021.

The extent of the impact of Vitoria's informal settlement on vegetation cover and water bodies was calculated by the Normalized Difference Vegetation Index (NDVI), after atmospheric correction, based on images obtained from the Landsat 8/OLI satellite on the USGS website (<https://earthexplorer.usgs.gov/>), processed by ArcGis software. For this, satellite images

obtained from May 2013 to July 2021 were assessed. NDVI is a sensitive indicator used for the remote sensing of green vegetation and it ranges from -1 to +1; and the higher values indicate the presence of photosynthetically active, green vegetation [6]. NDVI consists of determining a ratio of the difference and sum between the reflectance at less absorbing bands in the near-infrared (pNIR) and the highly absorbing band in the visible red (pred) [7]:

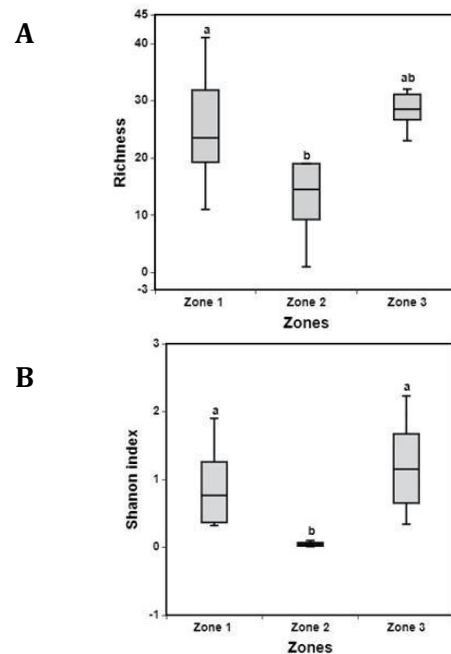
Figure 4. Comparison of richness (A) and Shannon's diversity index (B) of species found in 3 studied zones 1, 2 and 3: Analysis of variance was performed using Anova and Multivariate comparisons were performed using Tukey's test at significative level of  $p \leq 5\%$ .

Species richness (number of species) was assessed as well as the Shannon-weaver biodiversity index using the following equation:

$\Sigma$  = Sum symbol; and  $\ln$  = Napierian logarithm. The results were analysed using one-way ANOVA ( $p \leq 0.05$ ) and the means was compared using Tukey's test at significative level of  $p \leq 5\%$ .
