Nature-Based Solutions to Rehabilitate Erosion Processes in a Brazilian Urban Settlement

Abstract -- The study site, an informal settlement in Contagem, within the Belo Horizonte metropolitan area, faces severe erosional processes. This degradation stems from urban expansion's profound impact on a landscape characterized by a high density of headwaters. The rapid and intense urbanization has significantly altered natural hydrological pathways, leading to gully formation in preserved areas and ravines in urbanized sectors. Given this critical environmental context, rehabilitation procedures employing nature-based solutions (NBS) were recommended. A model was proposed for the restoration of degraded water channels, stabilization of eroded slopes, and improvement of urban thoroughfares, directly targeting areas most impacted by erosional phenomena. Consequently, a three-tiered restoration framework was established for the site: 1-channel restoration, focused on managing water velocity and flow dynamics; 2-slope restoration, implemented in two stages—physical stabilization via berm construction along contour water lines and biological stabilization through the planting of herbaceous a

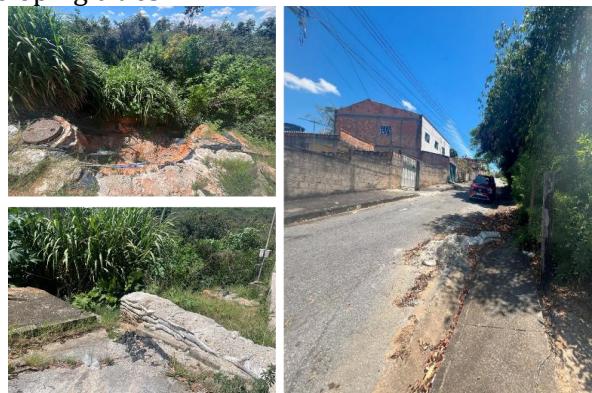
Figure 2. Erosive process on the study site

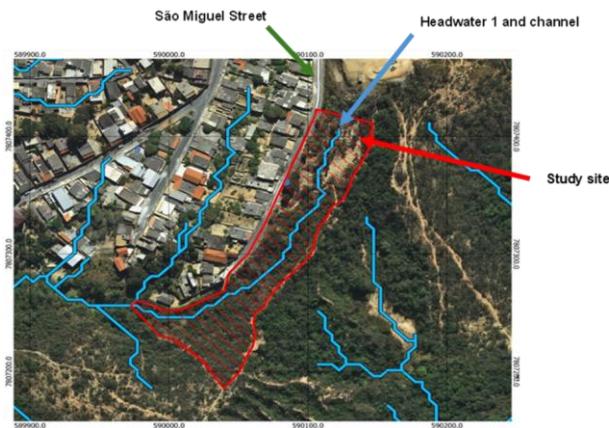
Figure 3: Study site.

The study site (Figure 3) is located in the city of Contagem in the state of Minas Gerais. The region is known as Estaleiro, which is an informal settlement in the northwest part of the city. The coordinates of the study site are latitude: 19°49'38.71"S and longitude 44°8'22.87"W. The study site has been suffering interference from the high-speed pressure of the urban process, which resulted in formation of many informal settlements. Due to the high number of headwaters in the area, the intense urbanization process became a harmful factor to the natural headwater flow which resulted in intensive erosion process in the urban area and gullies in the preserved areas. Considering this context, it is recommended to assure the protection and direction of the water flow.

To reconstruct the natural drainage channel (Figure 3), contour lines were used to identify the headwater point, which was located near the 900-meter elevation mark. To determine the dimensions of the conduit channel, it was necessary to calculate the terrain slope (%). To estimate the average flow rate rainfall data was used in the IDF equation (Intensity, Duration, and Frequency – Equation), which is commonly used to estimate extreme rainfall events [11]. For this analysis, a return period (RP) of 20 years and a rainfall duration of 10 minutes were adopted. The local parameters k , a , b , and c required for the IDF equation (Equation 1) were obtained using Pluvio 2.1 software.

The conduit channel was dimensioned based on its flow capacity, as shown in Table 1. The results indicate that the channel has a low slope, which contributes to water retention and maintain natural flow. This supports the hypothesis that erosion in the area is primarily due to water stagnation. Therefore, is recommended increasing the channel's flow capacity by modifying its dimensions (Table 1, Figure 3).

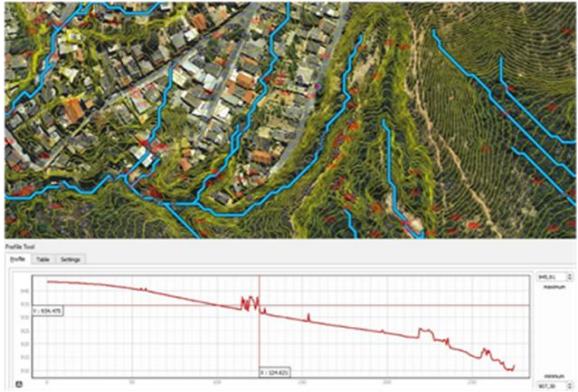
Figure 4: Flow direction of headwater 1 and C - Slope of São Miguel Street.

Figures 3 and 4 shows São Miguel Street slope rate, which justifies the rainfall water erosivity potential. Aiming stabilization, the slope was divided into three sections composed of varying numbers of berms or steps (Table 2). Each 1-meter berm or step will be stabilized

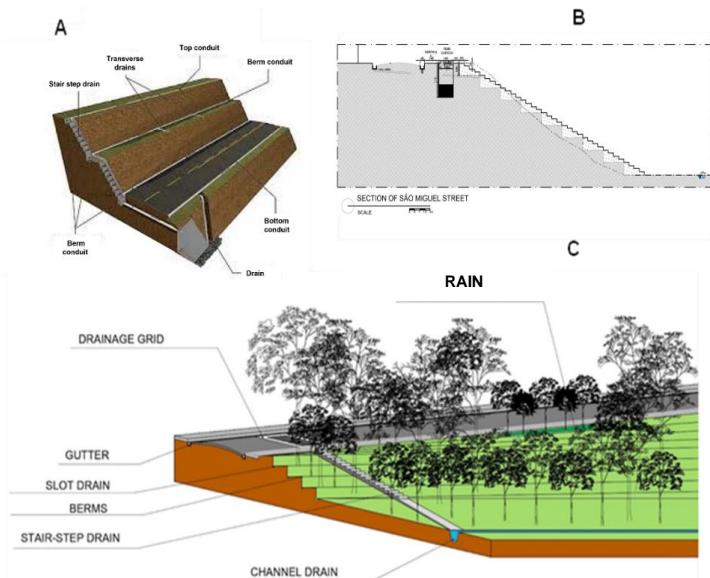
Figure 5: A: Schematic drawing of the slope with verges and water ladder [13] B: Schematic drawing of the verges with rain garden on the upper verge of the study site. C: Schematic drawing of São Miguel Street, rain garden and planted slope.

with a 40 cm high strip of stones at its base (Figure 5 A and 4B). Following physical stabilization, the slope will undergo biotic stabilization through the planting of native woody and herbaceous species.

- 1- Physical stabilization involves the construction of stepped slopes with berms anchored by rockfill, integrated with drainage channels and stair-step drain (Figure 5A and 5B) to ensure proper conduction of rainwater and runoff from São Miguel Street.
- 2- Biological stabilization, through the planting of native herbaceous and tree species (Figure 5C). To enhance soil aggregation and slope stability, we recommend inoculation plants with arbuscular mycorrhizal fungi (AMF), as supported by literature [14].

side gutter, a stone stair-step drain will be built to guide the water down to the main conduit channel (Figure 5C and Figure 6). From the third transverse drain onward, due to the steep slope, three rain gardens will be implemented on the first slope edge (Figure 6, Figure 7C and Figure 7D). The purpose of these rain gardens is to mitigate the excessive surface runoff on São Miguel Street, reducing the urban flooding, as well as the erosion slope risks [15].

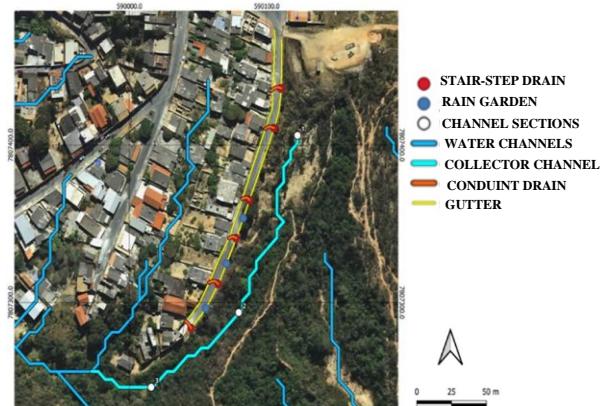
Figure 6: Positioning of the interventions to stabilize São Miguel Street.

To stabilize São Miguel Street, the construction of roadside gutters parallel to the sidewalks were proposed, both on the left and right sides, totaling 300 meters of length on each side. Each gutter will measure 0.20 meters in width and 0.20 meters in depth. These gutters will be interconnected by six transverse collector drains (Figure 6), each measuring 6 meters in length, 0.30 meters in height, and 0.20 meters in width, filled with 2.0 cm diameter stones. Each transverse drain will discharge into a stair-step drain on the slope, where each step will measure 0.5 m x 0.5 m x 0.25 m. Additionally, three rain gardens will be built on the first berm, each measuring 10 m x 1.4 m x 1.50 m.

Using Nature-based solution to stabilize São Miguel Street, the system of parallel gutters and transverse collector drains was designed to efficiently direct surface runoff to the main collector channel (Figure 6 and Figure 7A and 7B). These transverse drains will be covered by a protective grid (Figure 7A and Figure 7B). At the end of each transverse conduit drain, where it meets the right-

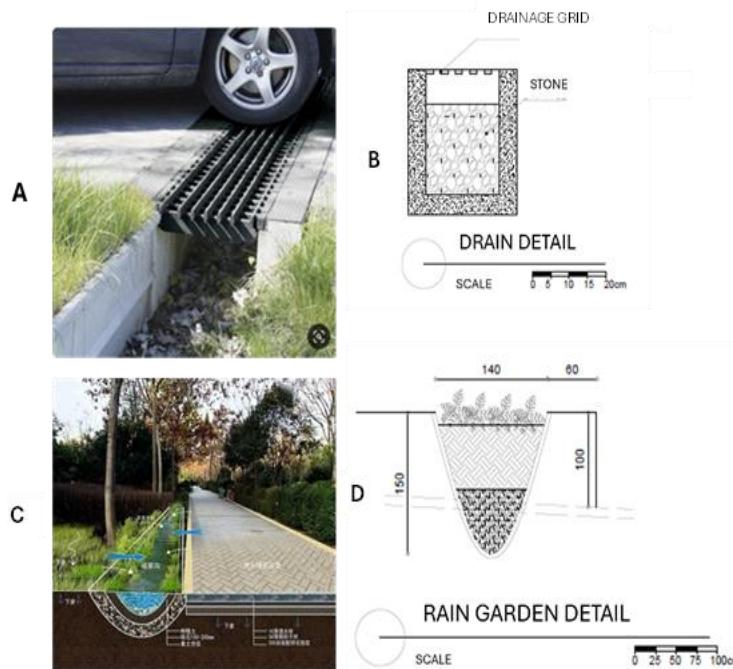
Figure 7: A- Drain grid on the street [16]. B- Schematic drawing of the proposed collector channel protected with grid. C- Rain Garden [17]. D- Schematic drawing of the proposed rain garden.

The urban impervious surfaces promoted by asphalt seal the soil layers and cause surface runoff, which leads to urban flooding. The rain garden is a bioretention system composed of layers of high permeability materials as stones and layers of stabilizing organic matter to also increase infiltration. In a rain garden the top layer is formed by native vegetation composed by herbaceous, shrubs and woody species which act as filters and soil stabilizer elements through soil aggregates formation [15].
